Manhole Inspection Summary

Manhole # S27G__006MH

Insp Date: **4/23/09 8:35 AM**

Location Address: **W FAYETTE ST**

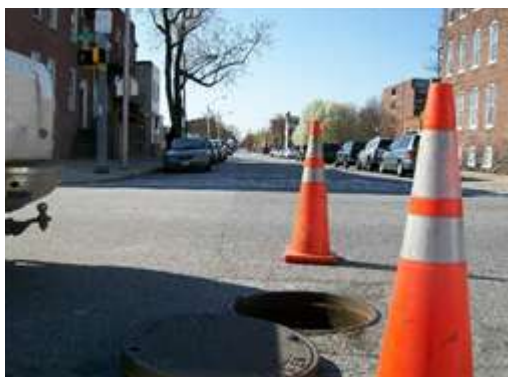
☐ Prev. Rehab Weather: **Dry** Subject To Ponding: **Sheeting**

EVIDENCE OF INFILTRATION DUE TO SHEETING FROM ROADWAY

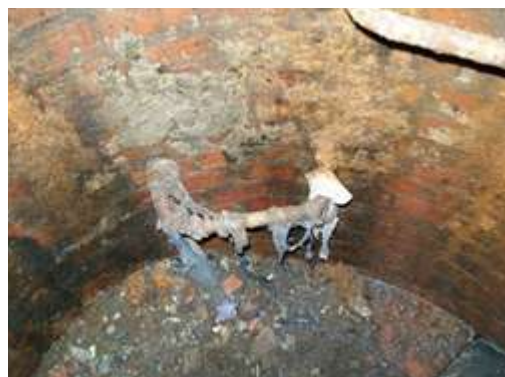
Defect 5

Surcharge ☒ **Evidence Of Surcharge** Depth: **3** (ft.) ☐ Active Surcharge Present

SURCHARGE EVIDENCE TO 3'

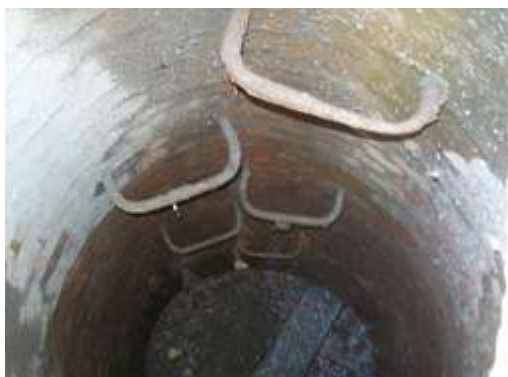
Defect 4

Steps Count: **6** Missing: **0** ☒ **Corroded**

CORRODED STEPS

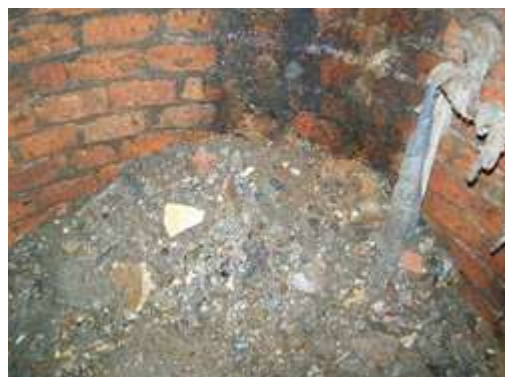
Defect 3

Condition: ☐ Sound ☐ Cracked ☐ Root Intrusion ☐ Deteriorated ☐ Leaks ☒ **Debris**

LOADS OF GRAVEL AND DEBRIS ON BENCH

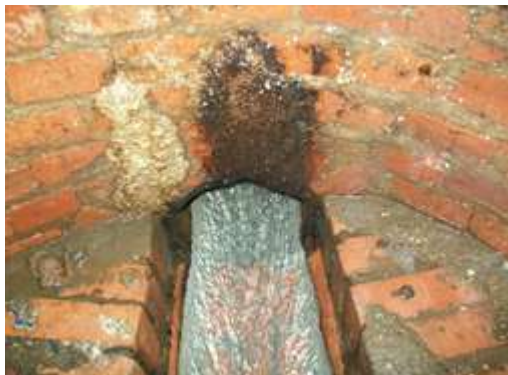
Defect 2

Infiltration: ☐ None ☐ Joint ☐ Cracks ☐ Mortar ☐ Roots ☒ **Wall**

EVIDENCE OF INFILTRATION FROM
BARREL WALL

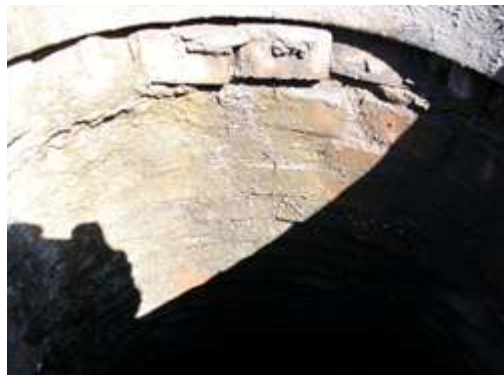
Defect 1

Condition: ☐ Sound ☐ Cracked ☐ Root Intrusion ☒ **Loose Brick** ☒ **Deteriorated**

DETERIORATION OF CHIMNEY -
LOOSE BRICKS

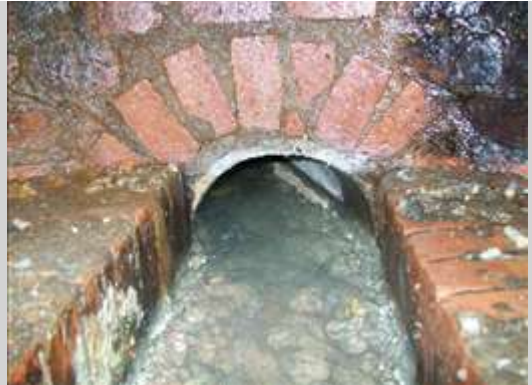
12 O'Clock Outflow

GREASE IN CHANNEL AND PIPE

Pipe Height: (in.) Direct
Pipe Material: **Clay** ☐ Pipe Lined
Invert Depth: **10.73** (ft.) Flow Characteristics: **Slow**
Deposits: ☐ None ☐ Mud ☐ Sludge ☐ Debris ☒ **Grease**
Silt Depth: **3** (in.) Deposits Extent: **Medium**
Infiltration: **None** Pipe Seal Cond: **Sound**

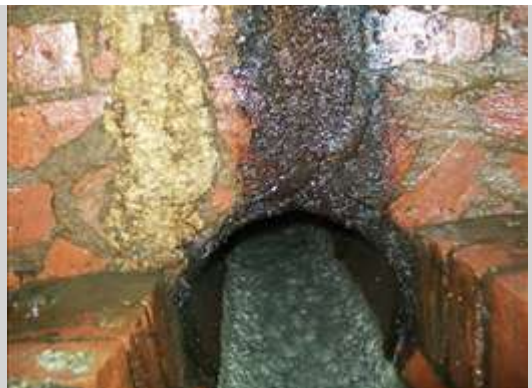
6 O'Clock Inflow

DEPOSITS OF GREASE IN PIPE CONNECTION

Pipe Height: (in.) Direct
Pipe Material: **Clay** ☐ Pipe Lined
Invert Depth: **10.53** (ft.) Flow Characteristics: **Slow**
Deposits: ☐ None ☐ Mud ☐ Sludge ☐ Debris ☒ **Grease**
Silt Depth: **2** (in.) Deposits Extent: **Light**
Infiltration: **None** Pipe Seal Cond: **Sound**
